Inspection of Stormwater Infrastructure in South Park Neighborhood, Houston

Summary for Community Partners

January 16, 2018

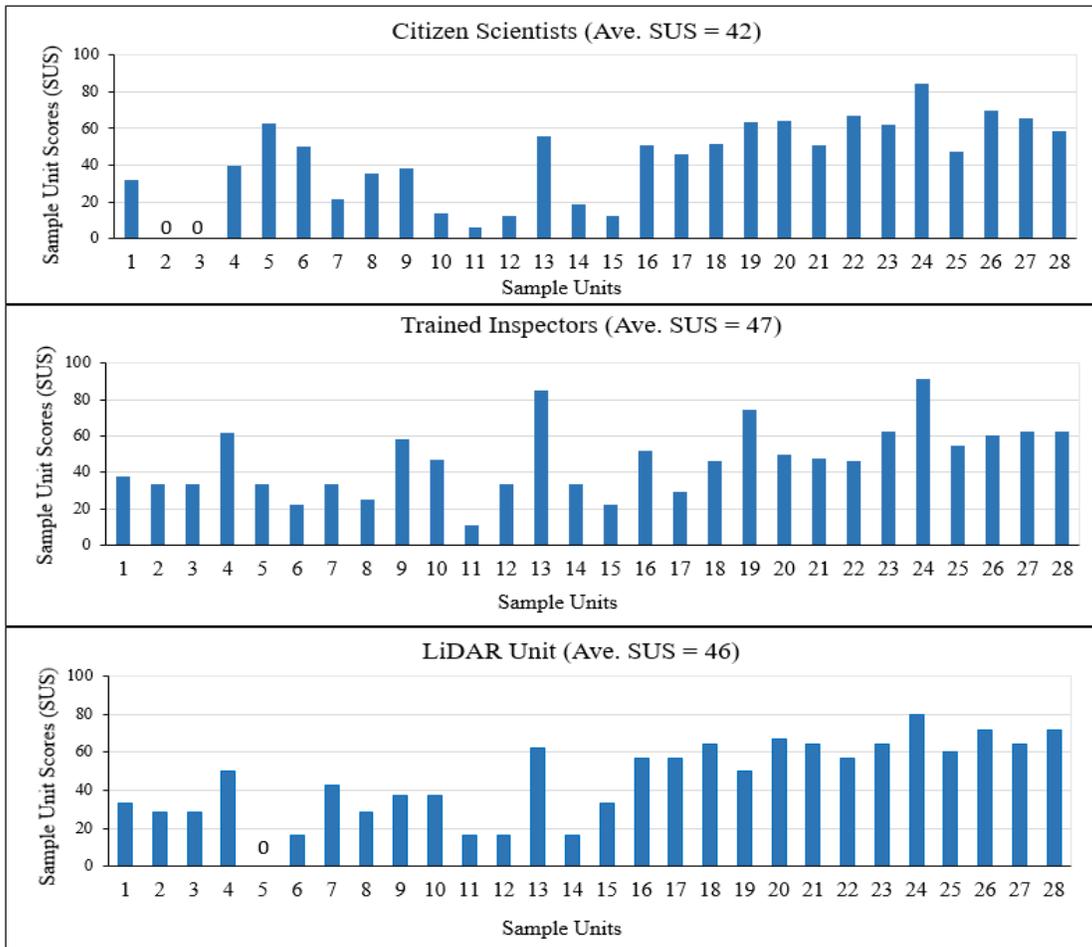
Figure 4: Computed Sample Unit Scores for South Park Neighborhood

For each sample unit, a 0-100 sample unit score (SUS) was computed as the ratio of the number of passing performance standards to the number of applicable performance standards, with 100 representing full compliance with the performance standards. SUSs obtained from the citizen scientists, trained inspectors, and LiDAR unit are shown in Figure 4. These scores show that most of the sample units failed more than half of the performance standards. The performance aspects of most failed performance standards are related to poor water flow issues and physical damage to drainage assets.
